The Magazine of Summerlee Transport Group

Workshop Report

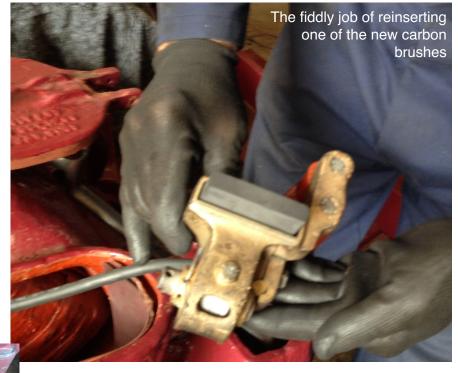
Charlie, Bobby and Alan nearing the end of the refurbishment of 1017s truck.

As indicated at the AGM several issues relating to the operation of this tram were discovered during September last year. Along with the need to replace the damaged axle box and sourcing a suitable supplier of the castings several other issues were discovered during the in depth investigation which also contributed toward the failure. The failure was primarily due to impact damage creating cracks in the side wall of the axle box. However there may have been an inherent weakness due to its original machining where steel wearing plates were inserted on either side of the housing in the belief that the metal was required at a critical support point in the

casting. These cracks were in an area of the casting which was not accessible and hidden by the steel wearing plate insert and all four of the boxes were found to have similar characteristics. As a result of these findings it was decided that all axle boxes should be replaced as the major cost of the repairs was in the manufacturing of the pattern used to cast the boxes. While this work was being undertaken the motors were removed from the truck and bearing failure and other electrical issues were highlighted and these were also included within the work to be undertaken at this time. As the truck had been stripped of its major components work on re-profiling the tyres was undertaken by a specialist contractor and this has restored the tyres to an acceptable condition. As we near the completion of these works on the truck additional issues have been

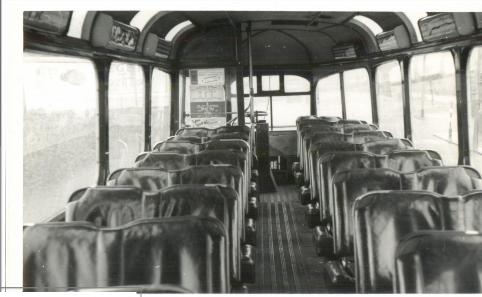
Upper deck interior note the all leather upholstery probably because smoking was permitted upstairs.

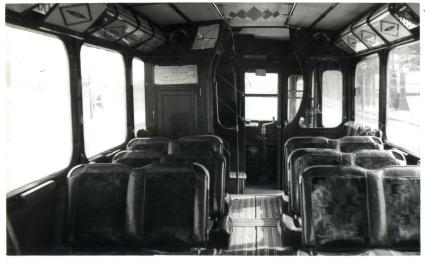
Lower deck interior note the moquette upholstery trimmed with leather.

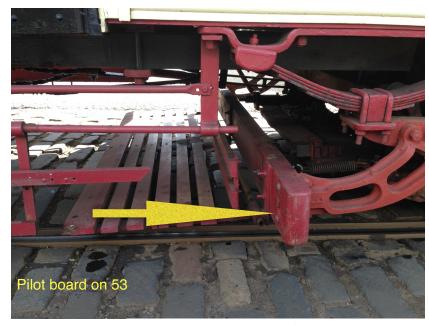
Slipper brake between wheels

- 2) Slipper brake is a term applied to the earliest type of track brake normally used by systems with steep hills. The track shoes were applied by hand with a horizontally mounted wheel on the hand brake column just below the goose neck hand brake handle. Later track brakes used magnetic current applied by the braking notches as with 1017.
- 3) They make current collection equipment particularly pantographs for heavy and light rail use.
- 4) Inside the controller cover, being the contacts making the connection with the drum contacts.
- 5) The canopy switch is situated under the drivers' seat. Not a very easy to reach or safe location!

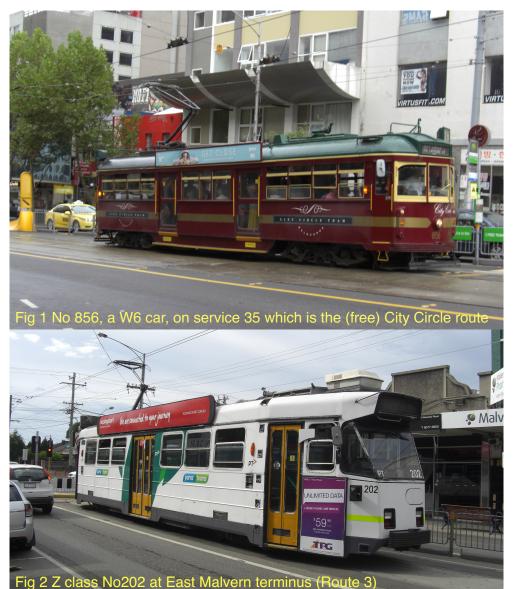
The standard tram of Melbourne used to be the W class, latterly the W6. In the 1970s the more modern Z class was introduced but time has passed and the withdrawal of the Z class is now well underway.

Initially the Z class trams were fitted with fixed head trolley poles but these were later replaced by pantographs.

The fixed head trolley required the overhead to be precisely related to the tracks, on straight track to be straight with virtually no deviation. With the pantograph installed the overhead should have been modified to introduce a stagger to prevent excessive wear of the contact strip. However, observation on a recent trip failed to see any stagger.
