The newsletter of the Summerlee Transport Group

Golden Jubilee Edition

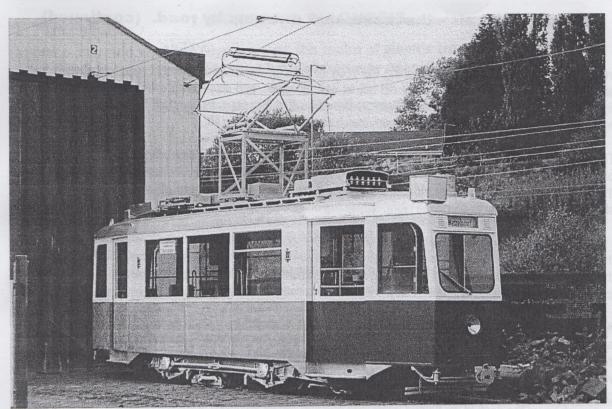
Graz 225 is now receiving attention in preparation for its return to the operating fleet. Leaks in the roof have been identified, repaired, and sealed, and the exterior rubbed down, prepared and undercoated. The car will appear in a special Jubilee colour scheme, based loosely on Leeds 602.

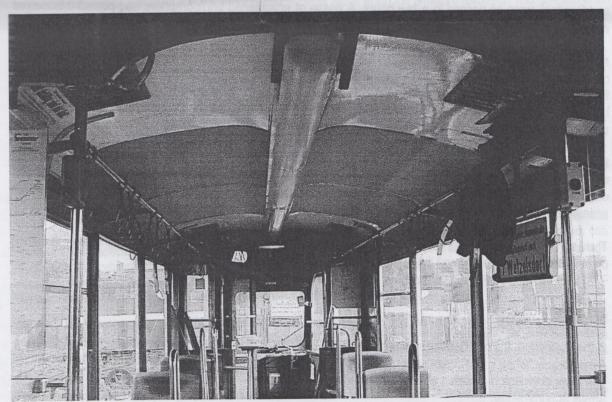
Replacement of the pantograph insulators also required removal and substitution of several ceiling panels. Fortunately the Group is well endowed with tall members, which proved a boon during this awkward task.

Davie Plunkett and Bruce Discombe have been trying to cure the faults on 225 and have replaced the damaged insulators under the pantograph.

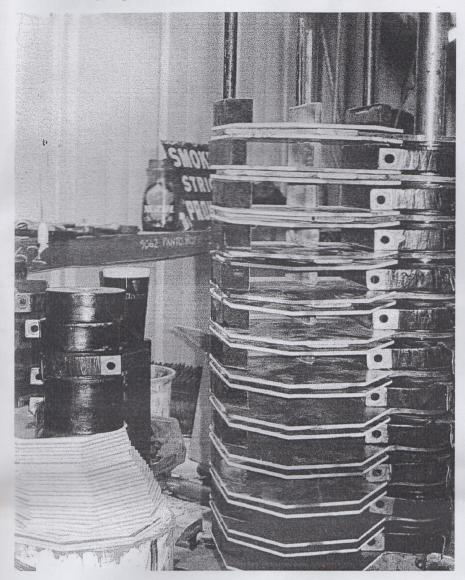
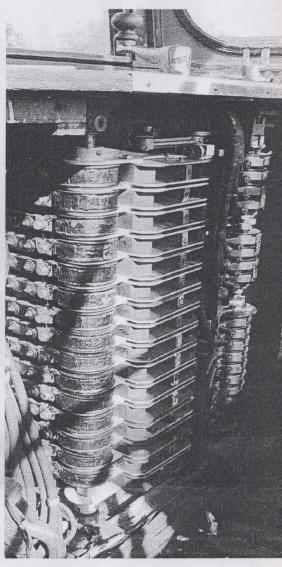
Above left: Flashguards from one of Graz 225's controllers being re-assembled on the bench using new insulating components, and right, the finished unit as installed in the controller.

Finally, the team have been working away to try and solve the electrical problems that have plagued the Graz car, resulting in it being out of traffic for some years. It was found that the asbestos flash guards inside both controllers had perished, allowing stray current to form a short circuit to earth in a most spectacular fashion, and explained the flashes, bangs, smoke and blown fuses which had occurred dramatically every time the car was tested. The asbestos was removed and replaced, and the car will now be able to return to service after it receives some general cosmetic refurbishment. As we go to press, this is taking place.
